## TECHNICAL MEMORANDUM

**TO:** MARY PERREA, FOUR MILE BROOK STREAM TEAM  
**FROM:** BRIAN GRABER, FLUVIAL GEOMORPHOLOGIST, RIVERWAYS PROGRAM  
**SUBJECT:** FOUR MILE BROOK SITE VISIT AND ASSESSMENT  
**DATE:** 12/2/2004  
**CC:** CARRIE BANKS, STREAM TEAM ORGANIZER, RIVERWAYS PROGRAM  
JOAN KIMBALL, DIRECTOR, RIVERWAYS PROGRAM

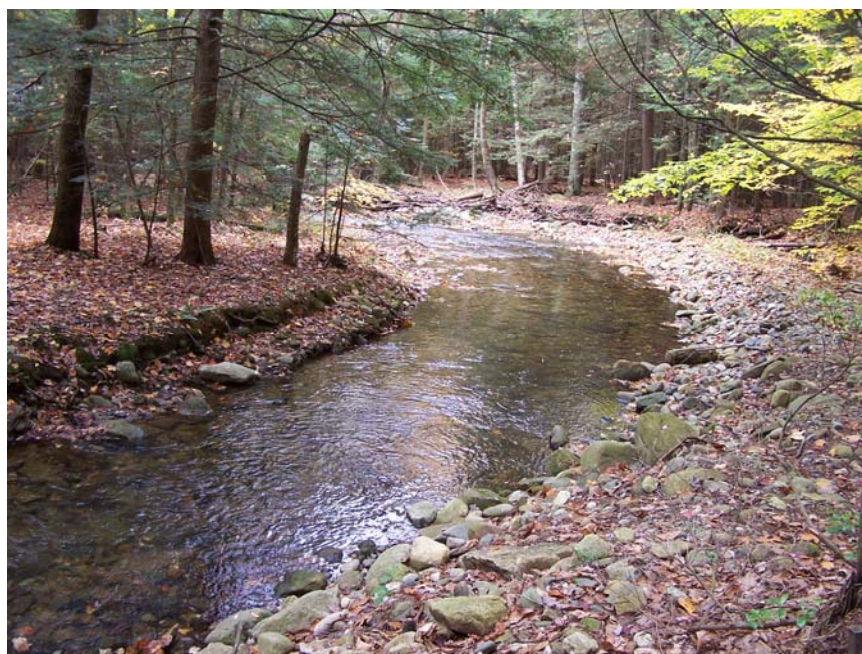
**Figure 1.** A portion of the lower reaches of Four Mile Brook.

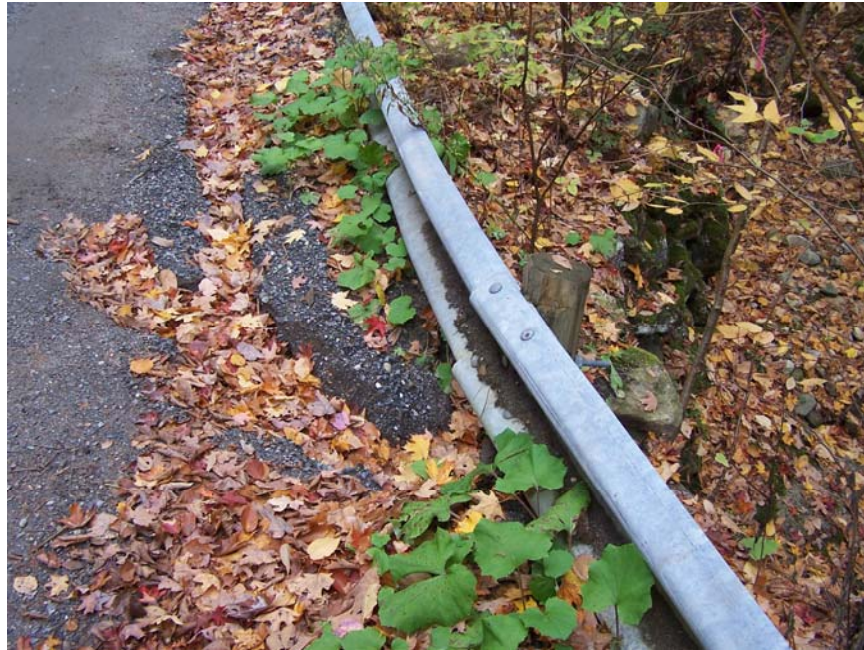
paths are directed toward the stream. Four Mile Brook Road may be a significant source of sediment to the brook. While the high stream power appears to clear much of this material from most of Four Mile Brook, it probably deposits downstream near where Four Mile Brook connects with the Connecticut or it ends up in the Connecticut.

**Figure 2.** The drainage pattern along this road sends road runoff directly into Four Mile Brook carrying sediment and other contaminants from the road.

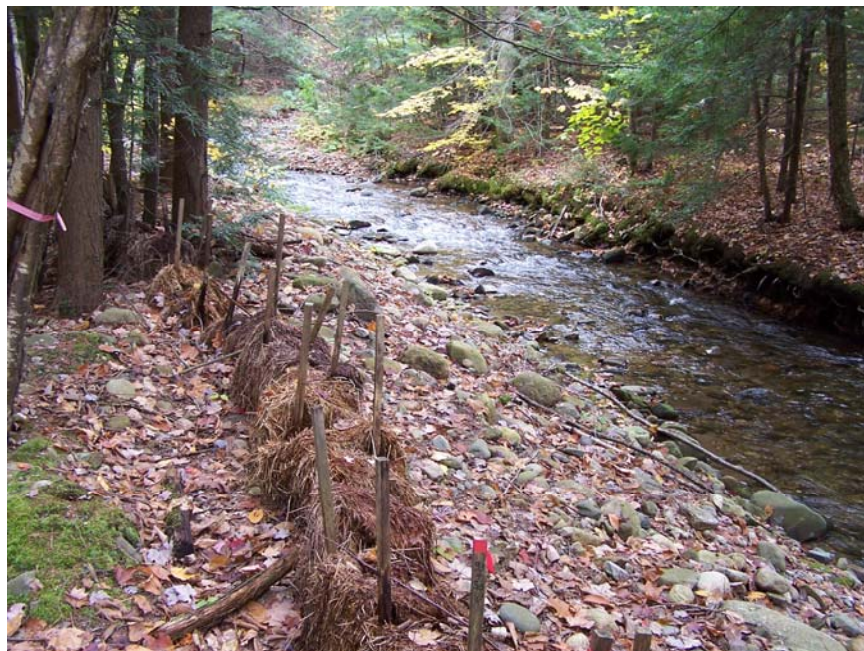
- **Riparian buffers**  
Vegetated riparian buffers help protect streams from runoff and sediment, decrease bank erosion, and provide shade and cover for a range of species. Along much of Four Mile Brook Road, the buffer appears to be inadequate to provide significant benefits and in some areas grass appears to be mowed right up to the edge of the brook. Elsewhere, buffers along the stream appear to be well vegetated and effective.

**Figure 3.** A portion of Four Mile Brook lacking a sufficient vegetated buffer. Four Mile Brook Road is immediately to the left of the photo.

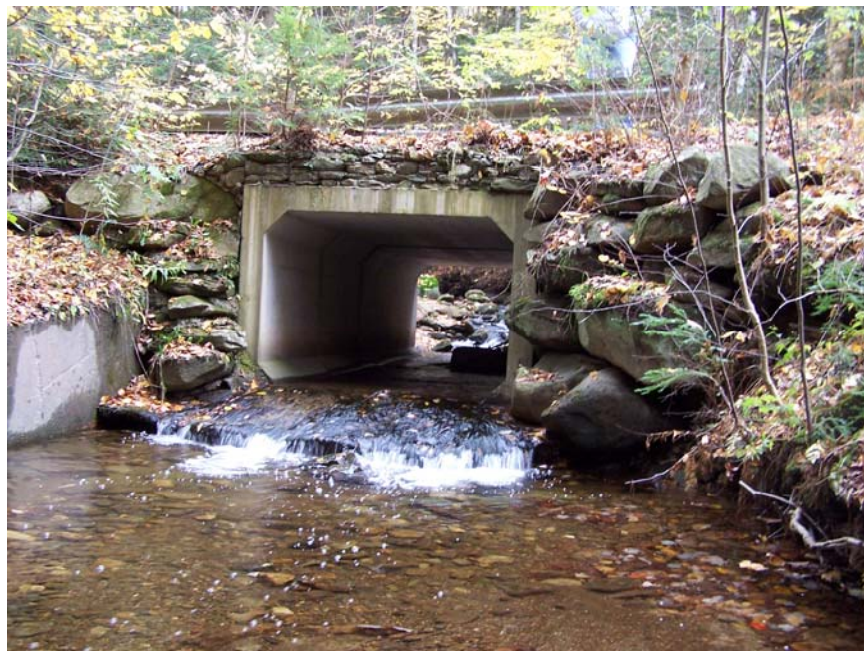
- **Habitat fragmentation – stream crossings**  
Roads can act as barriers to fish and wildlife movement where culverts are insufficiently sized or insufficiently set into the stream bed to allow passage. At least two culverts along Four Mile Brook Road appear to be acting as a barrier to some species.

**Figure 4.** A box culvert under Four Mile Brook Road is partially “perched” on the downstream end, impeding fish passage.

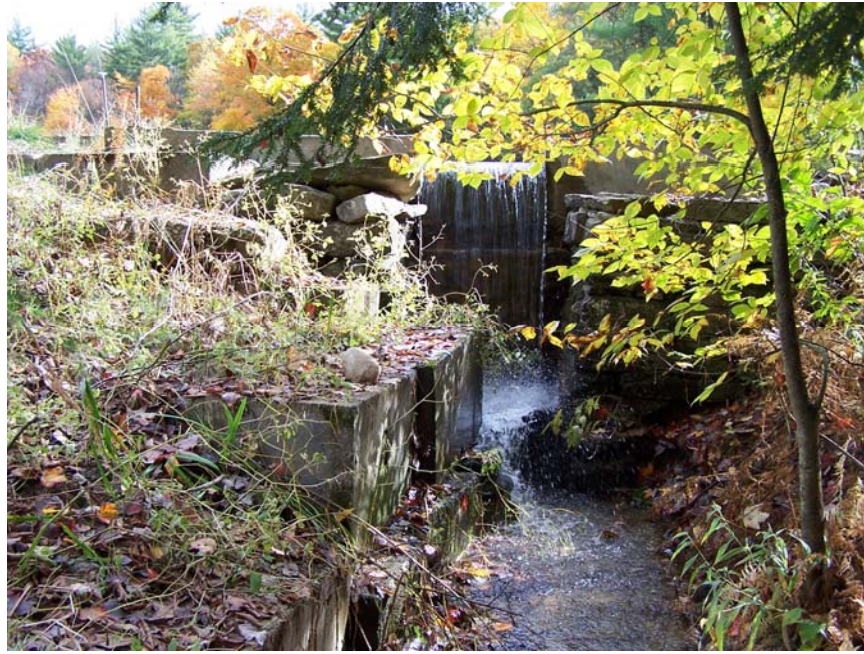
Mile Brook is unclear. The state database includes only one dam in the watershed, the Northfield Mountain Reservoir Dam. However, a small dam, not in the database, is readily visible from Four Mile Brook Road. In addition, air photos indicate that there may be several other dams scattered throughout the upper portions of the watershed.

**Figure 5.** A small dam off the main channel in the lower reaches of Four Mile Brook. Water is diverted from the mainstem of the brook into the impoundment behind this dam.

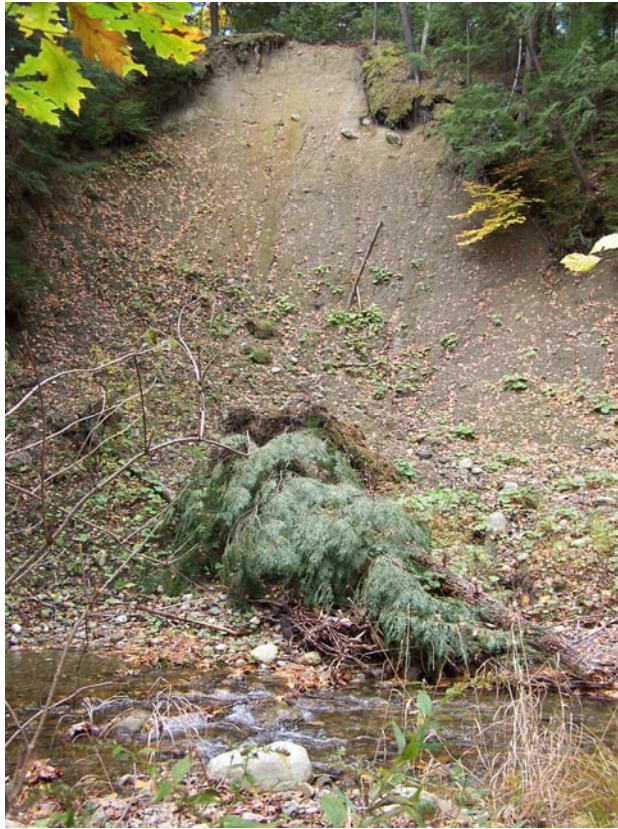
- Other habitat issues
  - Bluff erosion – because Four Mile Brook flows closely to the valley sides in areas, the high erosional power of the flow can cause excessive erosion. As the toe of slopes erodes away, the entire slope face can end up eroding into the stream. One such slope was noted in the lower watershed and there may be others. Bluff erosion is potentially a significant source of sediment into the stream that will ultimately deposit in the lower reaches of the brook or in the Connecticut River.

**Figure 6.** An eroding bluff along Four Mile Brook has likely resulted from the stream power eroding away the toe of the slope until the slope collapses into the stream. Portions of the brook flow along one or both valley walls.

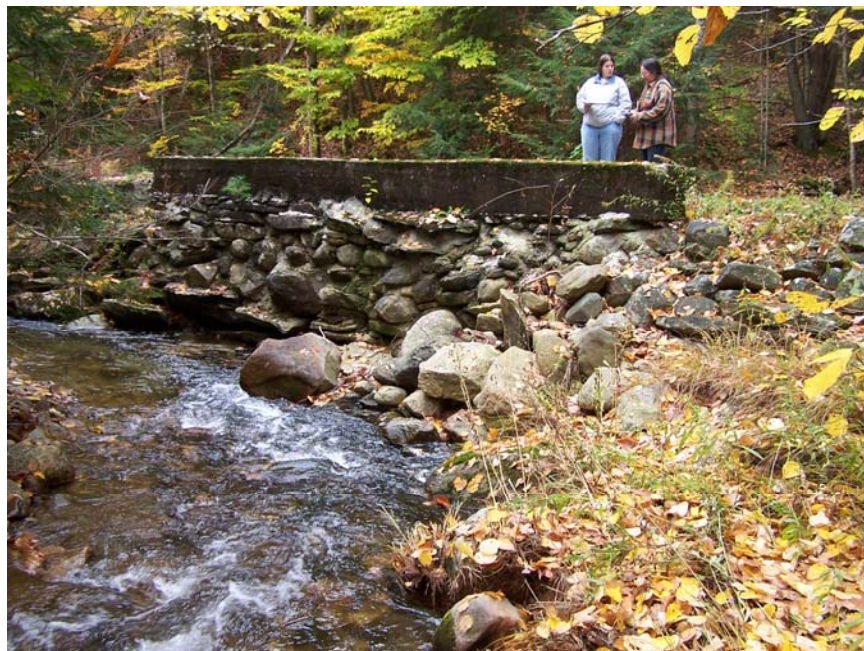
- Failing riprap – riprap placed to protect Four Mile Brook Road just upstream of where the road failed is falling into the stream. The failing riprap is isolated and does not seem to be creating a significant habitat problem, but other bioengineering stabilization techniques or combinations of bioengineering with “hard” engineering could provide protection for the road and banks and provide additional riparian habitat.

**Figure 7.** Rock riprap placed to reduce erosion on an outer bend of Four Mile Brook is partially collapsing into the stream. The brook jumped the bank just downstream of here during the September 1999 flood.

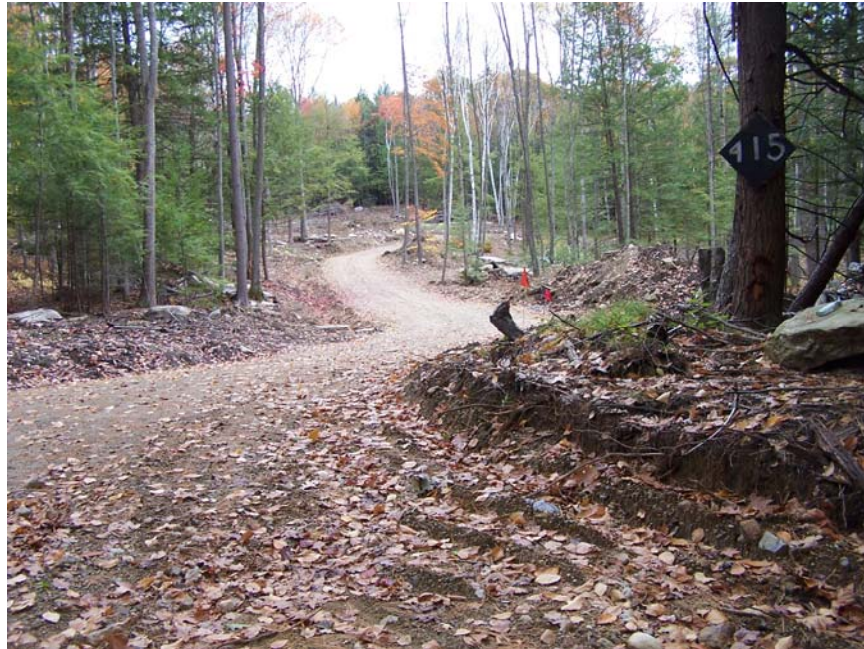
**Figure 8.** New development in the upper portions of Four Mile Brook. Thoughtful management can minimize the impacts of development, which typically include increased flood power and sediment load.

With expected increases in development in the upper watershed, a management plan could help guide development to have the least impacts on the stream corridor both short-term during construction and long-term from increased runoff and impervious area. A management plan would be worthwhile for protecting downstream property and infrastructure as well as for habitat. Using the information analyzed in a watershed assessment, a management plan could be developed to:

- help guide thoughtful development
- provide management practices for construction
- provide management practices for roads and road crossings including plans to retrofit or replace ineffective crossings
- reduce stream power and erosion
- protect and proactively restore habitat

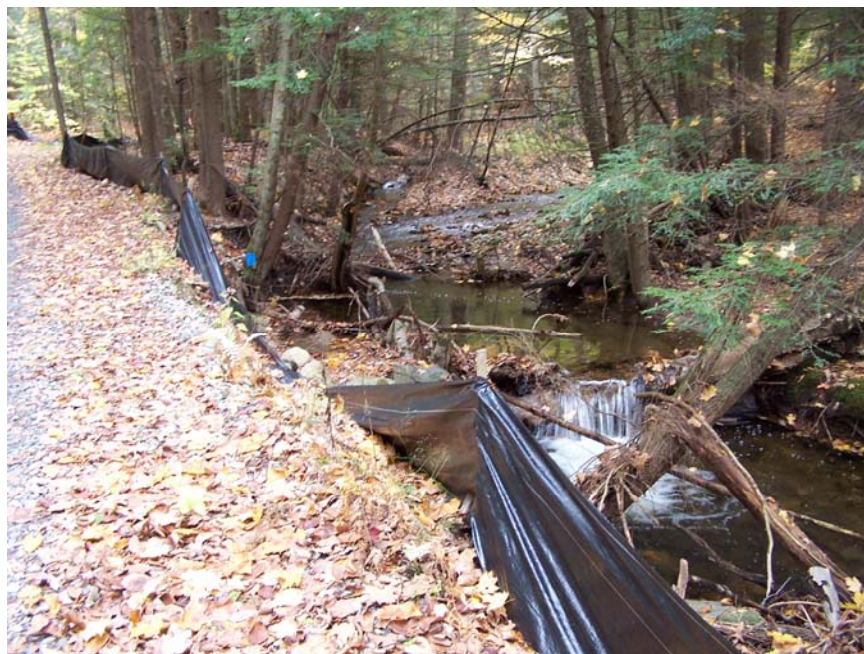
**Figure 9.** A collapsing silt fence is limiting its ability to protect Four Mile Brook from nearby construction runoff.
